PINETREE LAKE DAM

NDI ID Number PA-00784,
DER ID Number 45-244,

PHASE I INSPECTION REPORT.

APRIL 1980

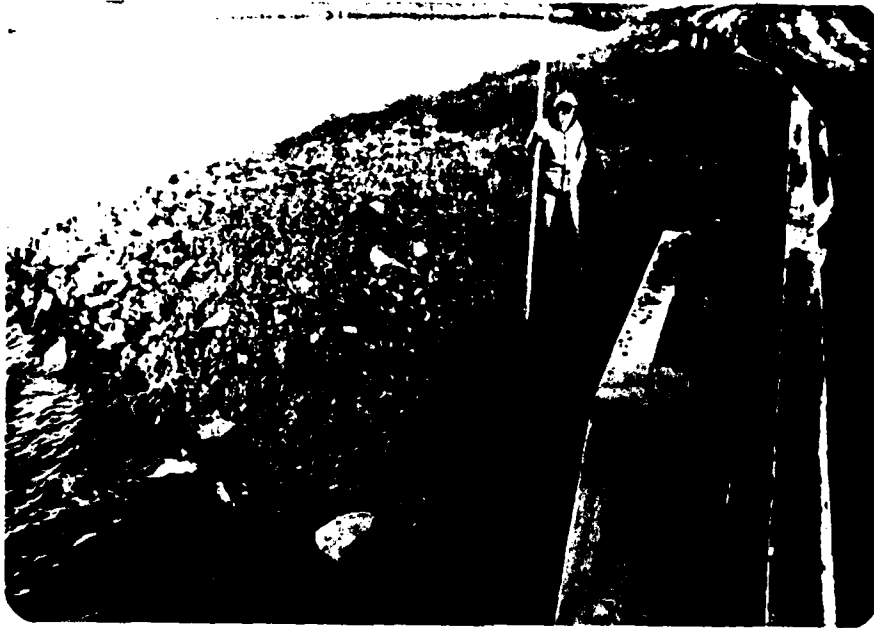
b. Embankment. The embankment is in good condition. The only deficiencies on the downstream slope are a few small bare areas. No erosion of the areas is evident. The riprap on the upstream slope is in good condition, but it is poorly graded in some areas. Just to the left of the spillway, the riprap is no larger than cobbles (Photograph C).

Even though the riprap on the upstream slope is poorly graded, there is no evidence of erosion; the riprap is apparently capable of resisting erosion due to wave action. However, the area adjacent to the spillway will be subject to relatively high velocity flows during a flood. It is probable that erosion would occur in this area because the riprap is poorly graded. However, it is not felt that the erosion would cause a failure of the dam if needed repairs were made immediately after each flood.

C. Upstream Slope Near Spillway.

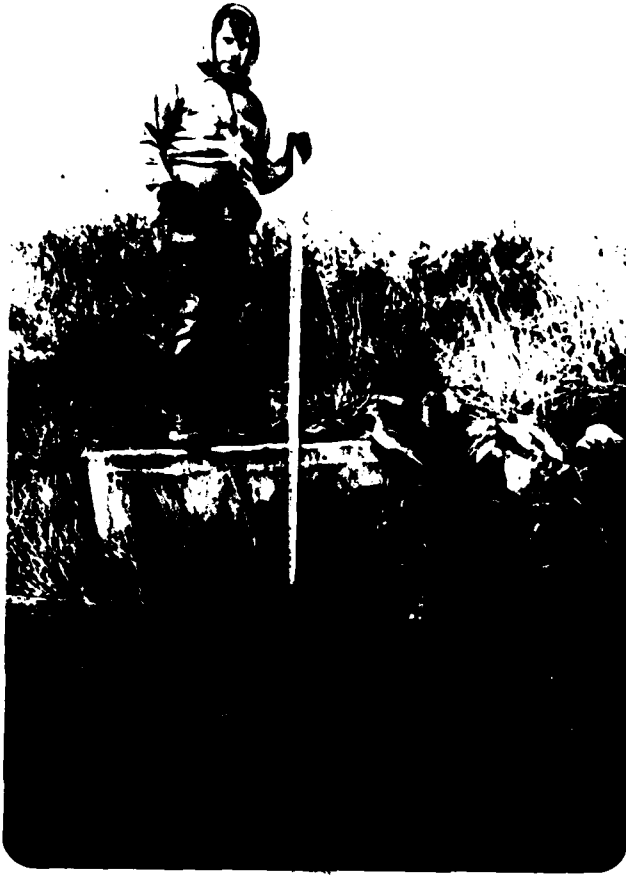
The outlet works is in good condition. The maintenance supervisor for the Emerald Lakes Association stated that the gate was operated annually and had been operated 3 weeks prior to the inspection without any problems. Because the gate was recently operated, the inspection team did not request that it be operated. Two reinforcing bars are lying on the bottom of the outlet works pipe and are protruding from the outfall. The pipe at the outfall is rusty, with some scaling noted (Photograph E).

The only structural problem at the outlet works is the rusty corrugated metal pipe. Since the pipe is encased in concrete, continued rusting would not be a hazard to the dam.

E. Outlet Works Outfall.

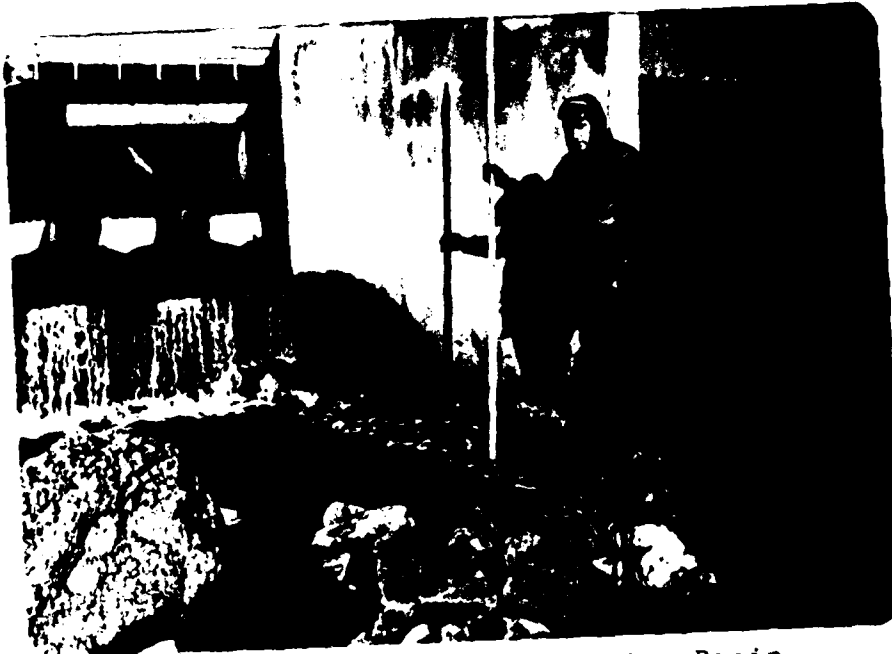
just upstream of the spillway bridge. There is leaching at one crack. The weep holes in the walls under the bridge are trickling. At the downstream end of the stilling basin, the left wingwall is undermined by 2 feet along most of its toe.

G. Retaining Wall Near Stilling Basin.

(1) Repair the undermining of the left wingwall at the stilling basin and provide erosion protection at the area.

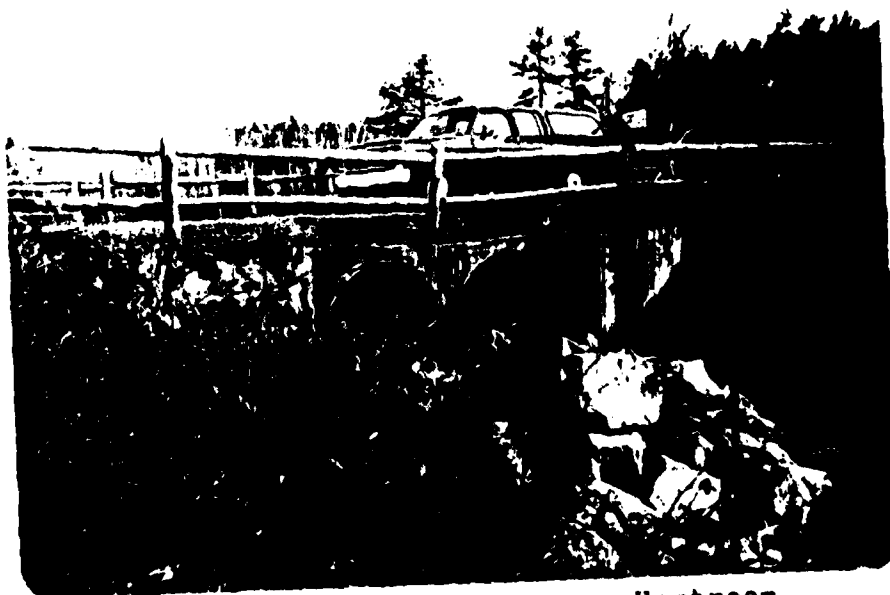
(2) Summary of Results. Pertinent results are tabulated at the end of Appendix D. The analysis reveals that Pinetree Lake Dam can pass the PMF with 0.5 foot of freeboard. The dam is rated at its design top elevation. As part of this study, it was also found that the outlet of the Emerald Lakes, located upstream from Pinetree Lake Dam, will be overtopped by 1.8 feet during the PMF.

H. Outlet at Emerald Lakes - Upstream
of Pinetree Lake Dam.
